Cracks in Flow liners and their Resolution

I. S. Raju and C. E. Harris¹

Summary

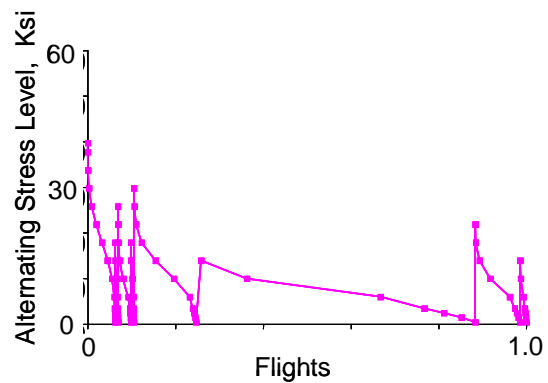
To determine the loads that the flow liners experience, two series of tests were conducted at the NASA Stennis Space center on gimbal joints with flow liners. The flight power levels were simulated in these tests. Extensive strain gage measurements were made and these data were used to infer the loading in the flow liners. In addition, the flow-physics team investigated large scale unsteady motions to the mean flow, back flow, changes in acoustic modes, cavitation, and heat transfer into the flow liner bellows cavity. The loads team, utilizing the results from the flow-physics team and the strain gage data, derived the loading spectra to estimate the load-time history of the liners during flight operations. The team's analyses also identified predominant modes that the liners experience during flight. The predominant mode for the upstream liner is a C9ND mode (C9ND refers to a complex 9-nodal diameter mode, and complex mode suggests both membrane and bending modes act simultaneously), while the downstream liner has 3 predominant modes – 3ND, C4ND, and 5ND. The fatigue loading spectra were determined from these loading spectra and the rainflow method of cycle counting. A typical fatigue spectrum is shown in Fig. 3.

Figure 3: A typical fatigue spectrum
